Your Inspection Report

857 E Davies Avenue
Coeur d'Alene, ID 83815

INSPECTION DATE:
Thursday, March 9, 2017

RE: Report No. 1022
857 E Davies Avenue
Coeur d'Alene, ID
83815

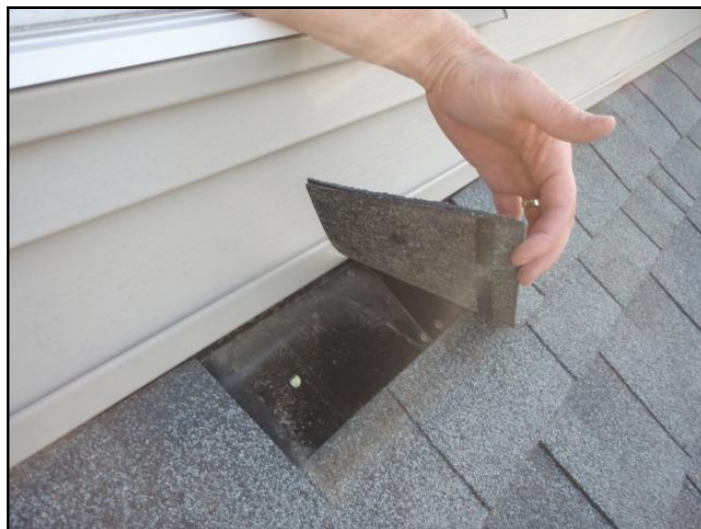
1. **Condition:** • Some of the shingles at the top of the lower roof are loose.

Location: South

Loose shingles

Task: Repair/secure

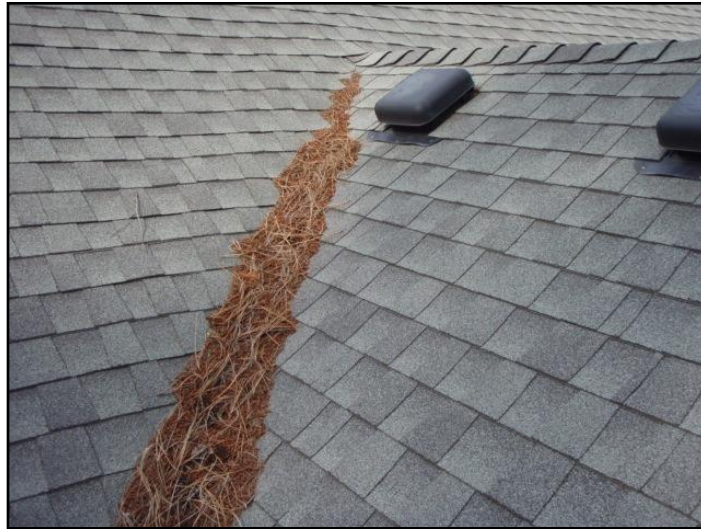
2. Condition: • Pine needles have gathered in the roof valleys

Implication(s): Premature aging of the shingles

Pine needles in a valley

Task: Clean

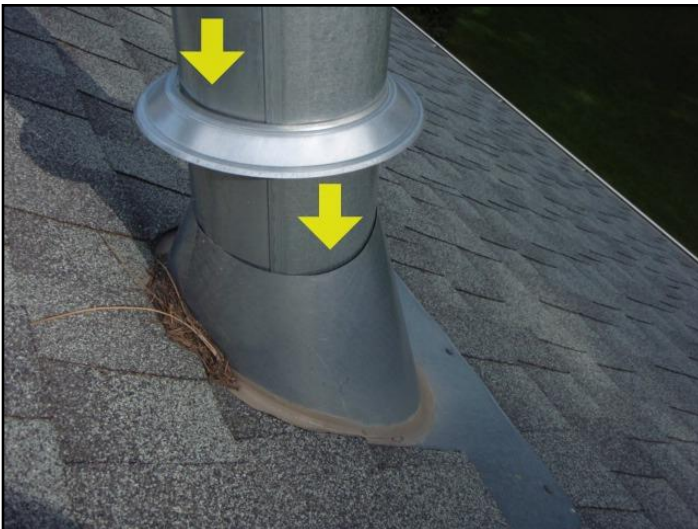
Gaps at the storm collar for the metal fireplace flue pipe allow water to enter the attic

Implication(s): Chance of water damage to contents, finishes and/or structure

Gaps at the storm collar

Task: Improve

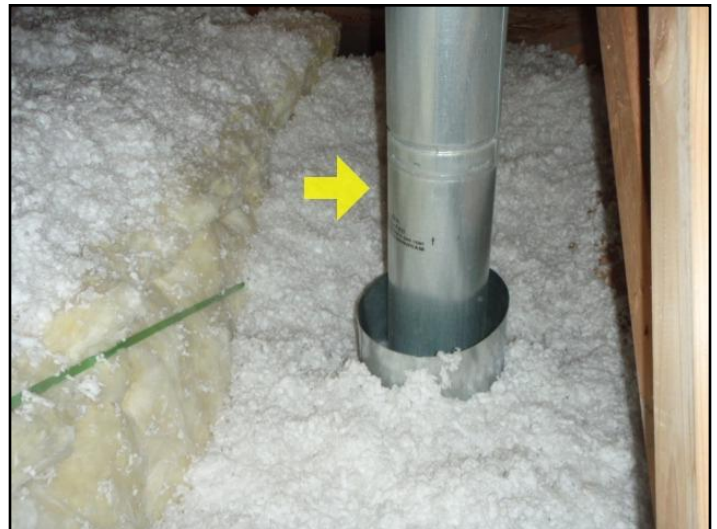
Water stains on vent pipe in attic

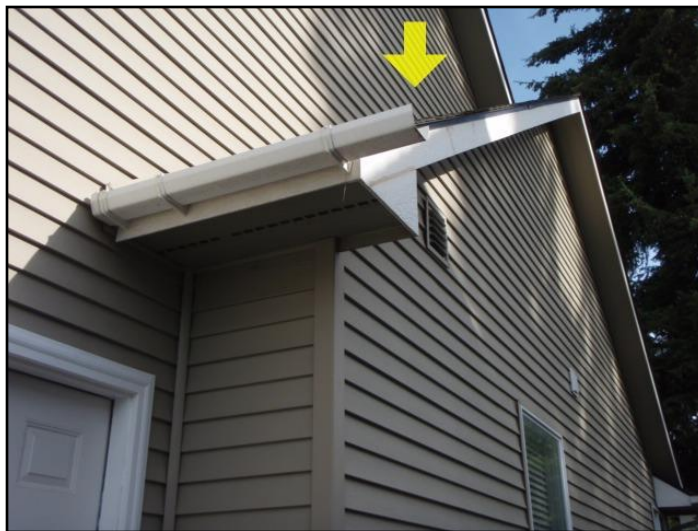
4. Condition: • [Missing](#)

Implication(s): Chance of water damage to contents, finishes and/or structure

Location: West Exterior Garage

Missing downspout at gutter

Task: Provide

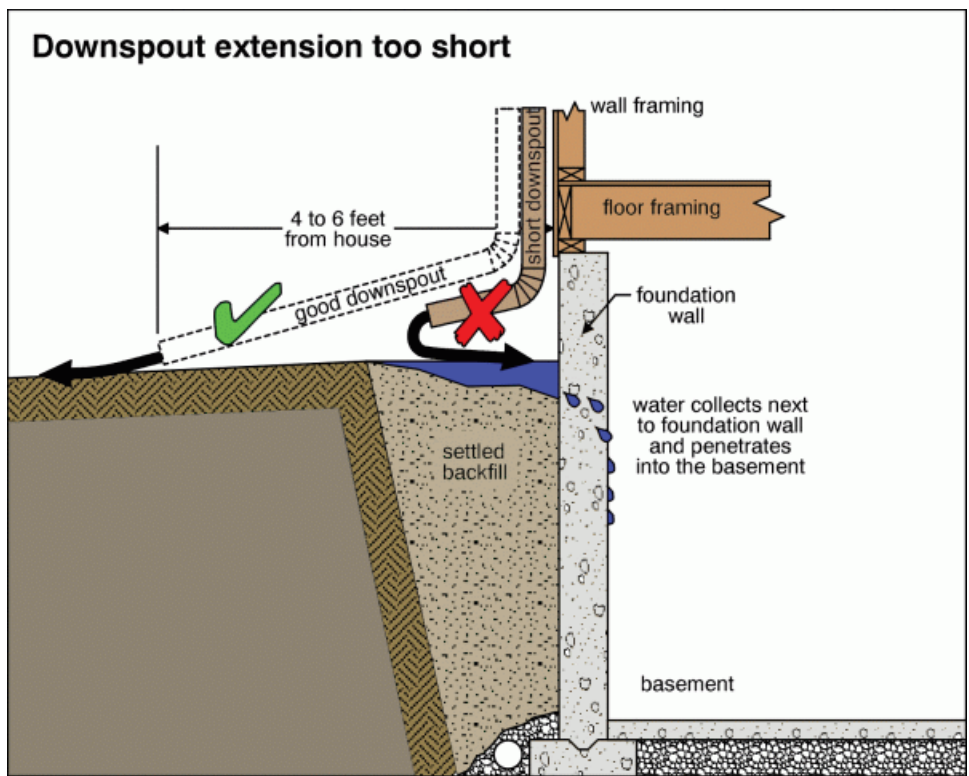
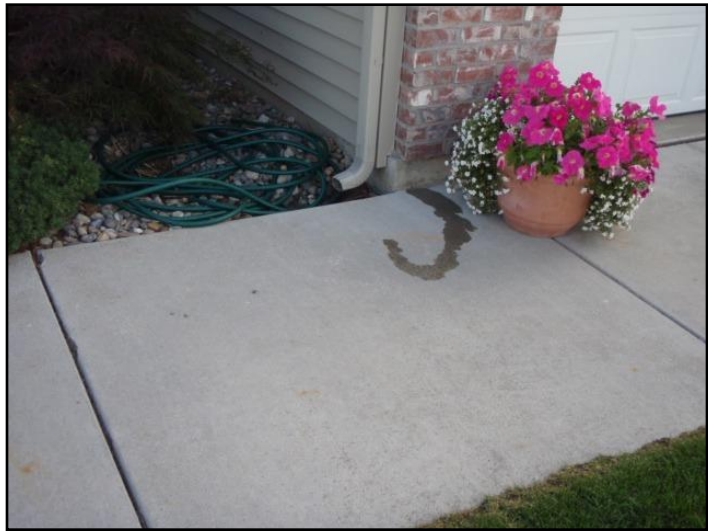
5. Condition: • [Downspouts end too close to building](#)

Implication(s): Chance of water damage to contents, finishes and/or structure

Location: North

Downspout discharges at foundation

Task: Improve

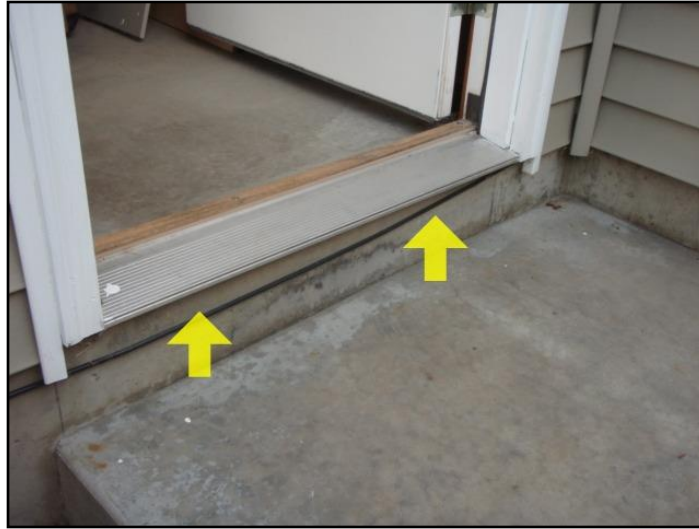
6. Condition: • The metal threshold for the exterior garage door is poorly supported

Location: West Exterior Garage

Metal threshold is poorly supported

Task: Improve

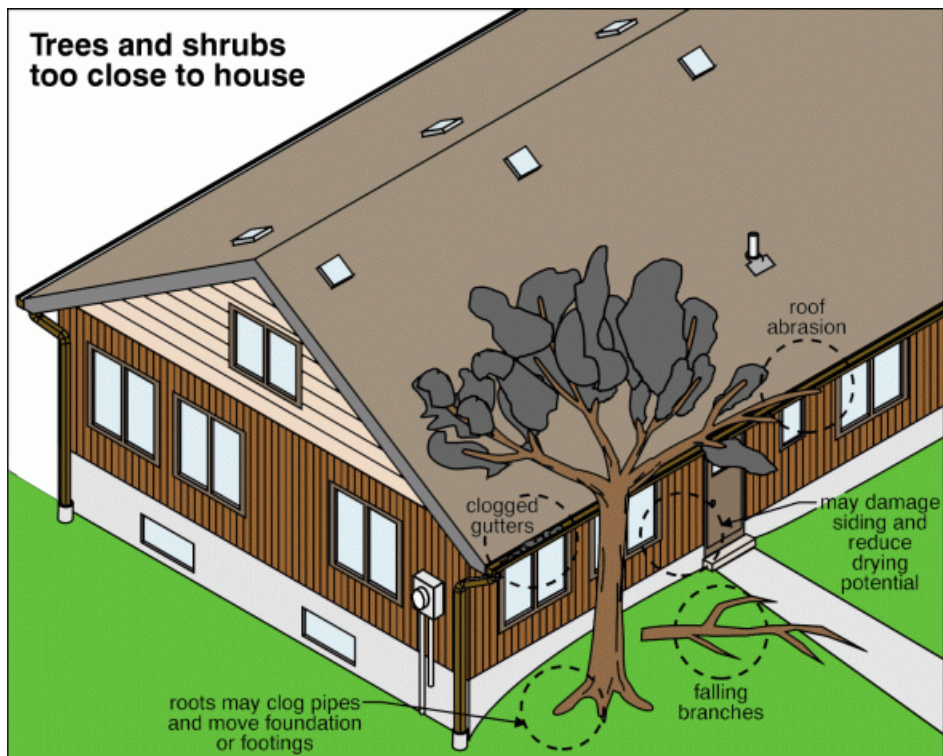
10. Condition: • [Trees or shrubs too close to building](#)

Implication(s): Material deterioration | Chance of pests entering building | Chance of water damage to contents, finishes and/or structure

Location: Various

Task: Improve

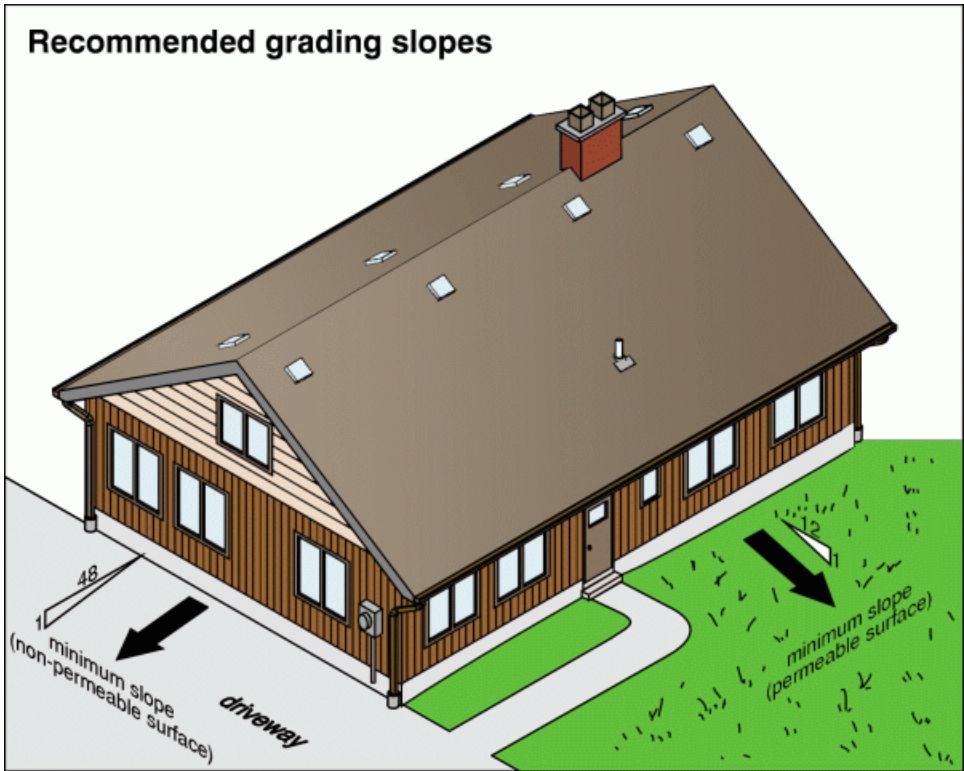
11. Condition: • [Improper slope](#)

Implication(s): Chance of water damage to contents, finishes and/or structure

Location: Various

Task: Improve

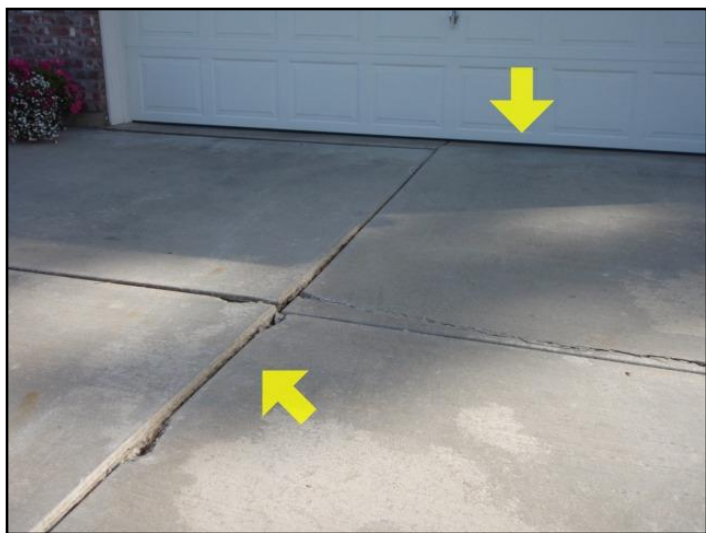
12. Condition: • [Uneven \(trip hazard\)](#)

Implication(s): Physical injury

Trip hazards on the driveway

Task: Improve

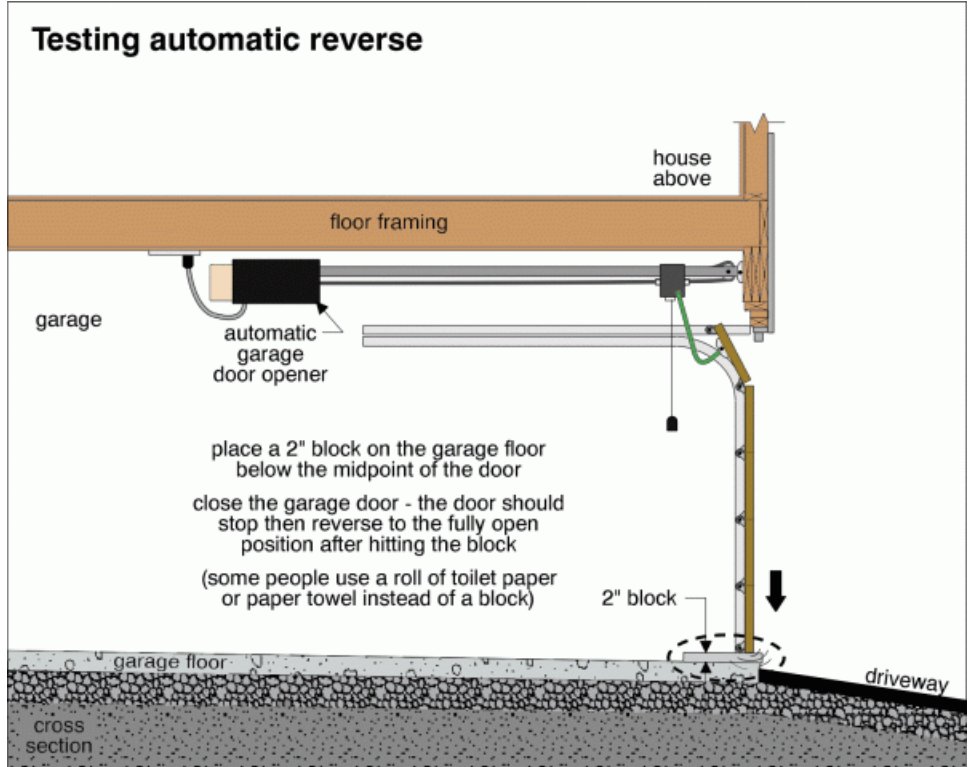
13. Condition: • [Fails to auto reverse](#)

Implication(s): Physical injury

Task: Improve

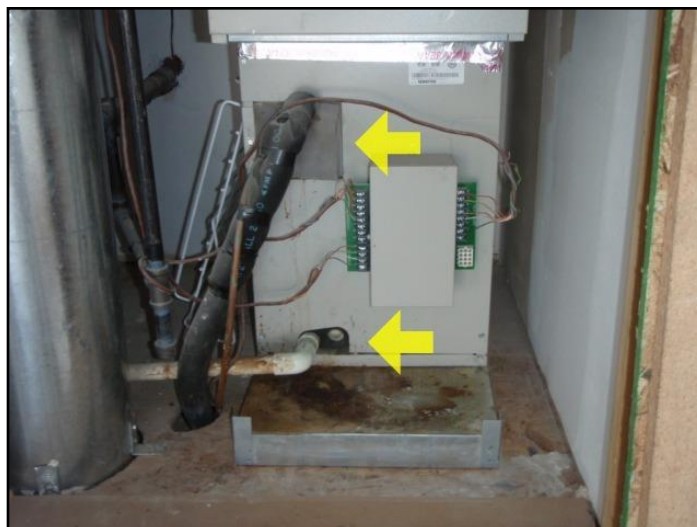
18. Condition: • [Leaky joints](#)

There is air leakage at the a-coil housing beneath the furnace

Implication(s): Reduced comfort | Increased heating costs

Location: Garage

Locations of air leakage

Task: Improve

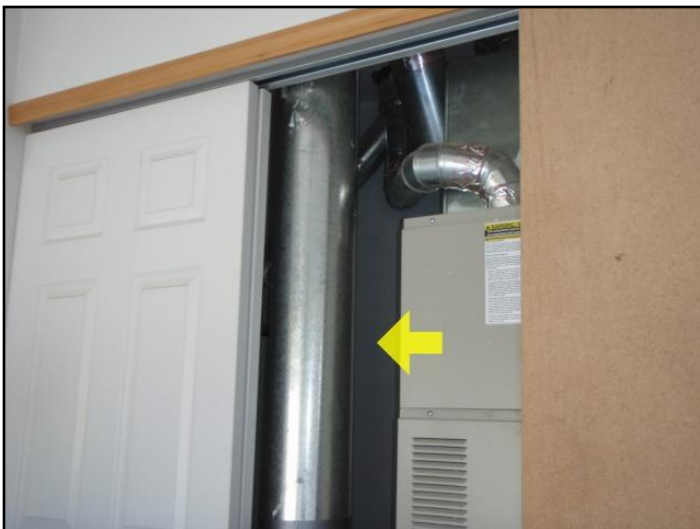
19. Condition: • [Insulation missing, damaged](#)

The supply duct for the bonus room is not insulated.

Implication(s): Reduced comfort | Increased heating costs

Non-insulated duct in garage

Task: Provide

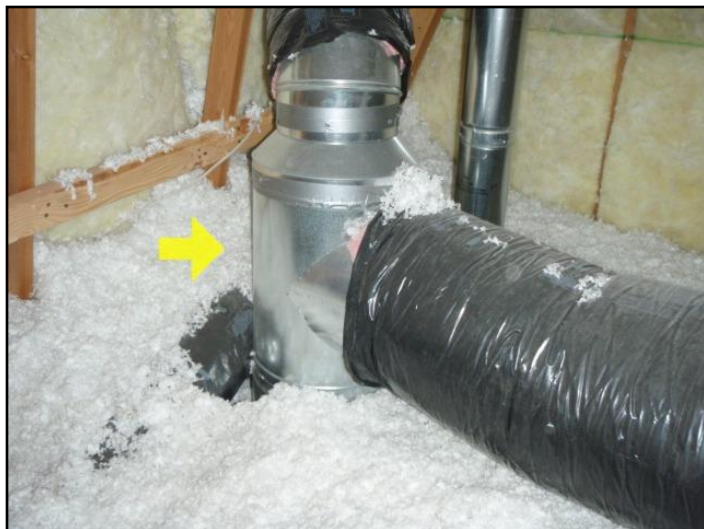
Non-insulated duct in attic

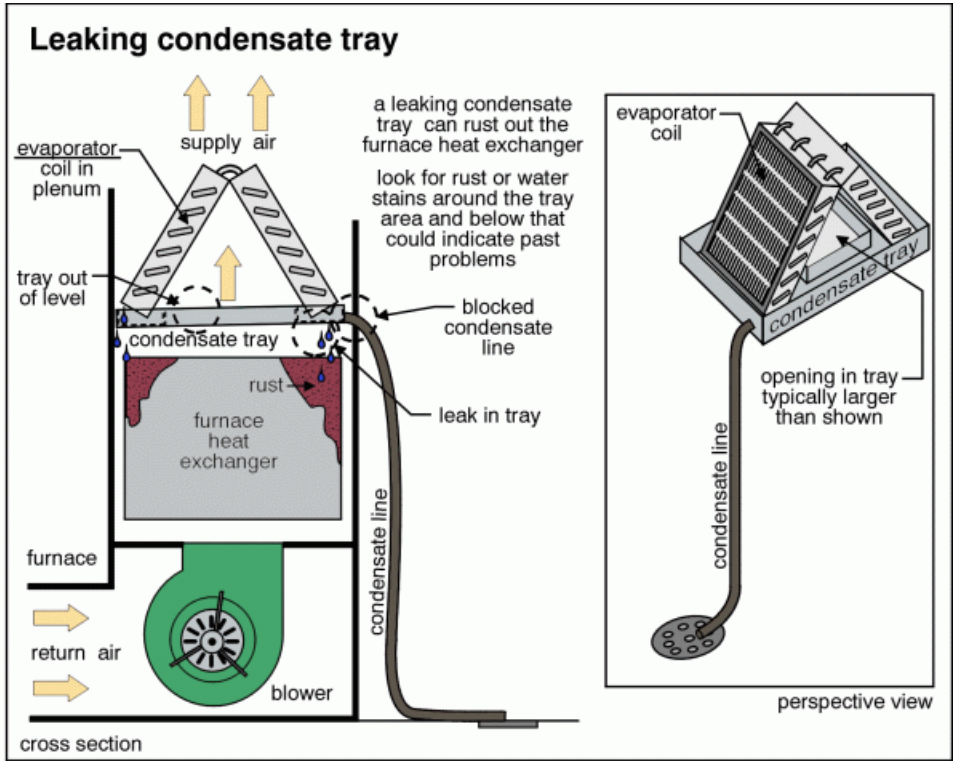
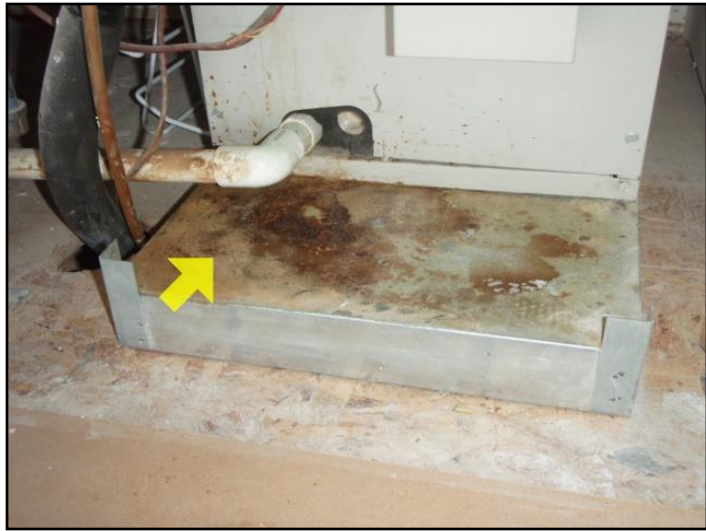
23. Condition: • [Rust or holes in pan](#)

Stains in front of the A-coil housing indicate previous condensate leakage. No leakage was noted at the time of inspection.

Implication(s): Chance of water damage to contents, finishes and/or structure | Damage to equipment

Stains indicate previous leakage

Task: Monitor

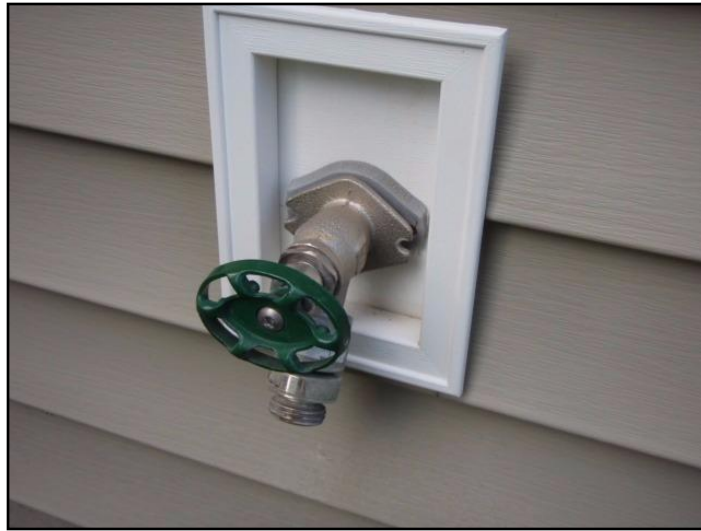
25. Condition: • [Loose](#)

Hose faucet is loose from wall

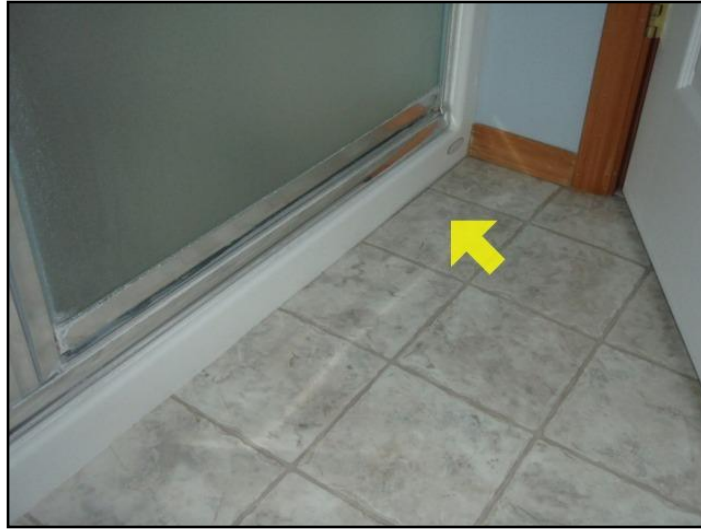
26. Condition: • [Loose or missing pieces](#)

The vinyl flooring at the master shower is loose

Implication(s): Trip or fall hazard | Cosmetic defects

Vinyl flooring is loose at shower

Task: Repair or Seal

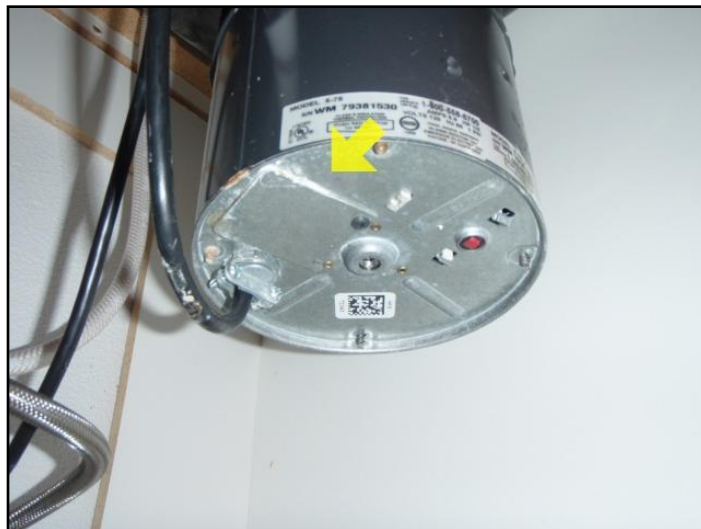
27. Condition: • Leak

There is a slow but active leak from the bottom of the disposal

Implication(s): Chance of water damage to contents, finishes and/or structure

Leak at disposal

Task: Repair or replace
